Manhole Inspection Summary

Manhole # S27S__007MH

Location Address: **1611 Ridgely**

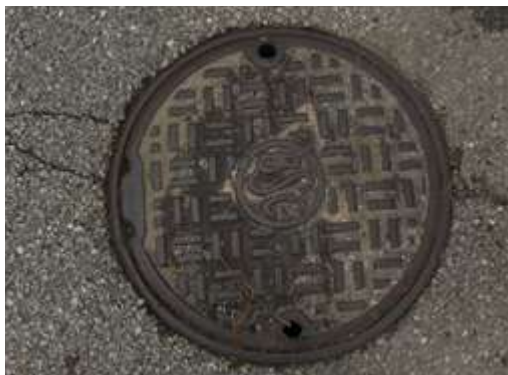
Cover View

Type: **Sanitary** Condition: **Sound** Cover Material: **Cast Iron**

Properties: ☐ Bolted ☒ Vented ☐ Water Tight ☐ Water Tight Insert

Frame Offset: **1.5** (in.) Condition: ☐ Sound ☐ Cracked ☒ **Leaks**

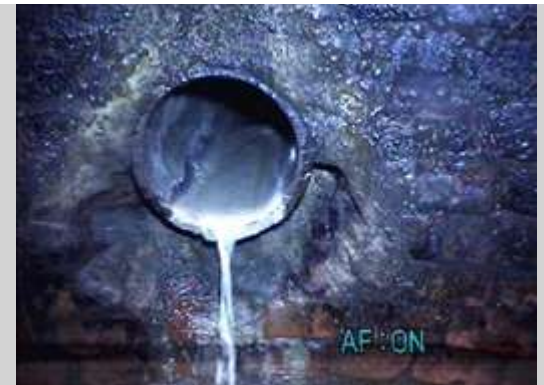
3 O'Clock Inflow

8 in. Circular Gravity Sewer
Pipe In @ 3 O'Clock

Drop In @ 3 O'Clock

Pipe Height: **8.4** (in.) Rod and Bar (Angled)
Pipe Material: **Clay** ☐ Pipe Lined
Invert Depth: **8.93** (ft.) Flow Characteristics: **Slow**
Deposits: ☒ None ☐ Mud ☐ Sludge ☐ Debris ☐ Grease
Silt Depth: **0** (in.) Deposits Extent:
Infiltration: **None** Pipe Seal Cond: **Sound**

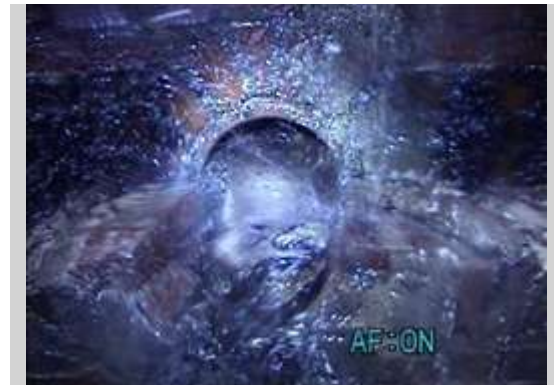
Drop: **Inside** Rod and Bar
Angled: **Yes** Reading: **11.71** (ft.)
Inv Depth: **12.71** (ft.)
Drop Condition: **Open**

Connects To: **House connection / Service line**

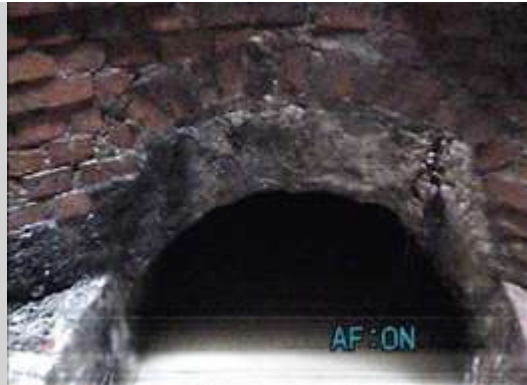
6 O'Clock Inflow

39 in. Circular Gravity Sewer

Pipe In @ 6 O'Clock

Pipe Height: **38.4** (in.) Rod and Bar (Angled)

Pipe Material: **Clay** ☐ Pipe Lined

Infiltration: **None** Pipe Seal Cond: **Sound**
